25º Encontro Nacional de Conservação Rodoviária (ENACOR)
48ª Reunião Anual de Pavimentação (RAPv)

Dynamic monitoring of an old long concrete bridge

Alberto Ortigão[1]; Waldeli Braz[2]; Claudio Martins[3] & Cristiana Ortigão[4]

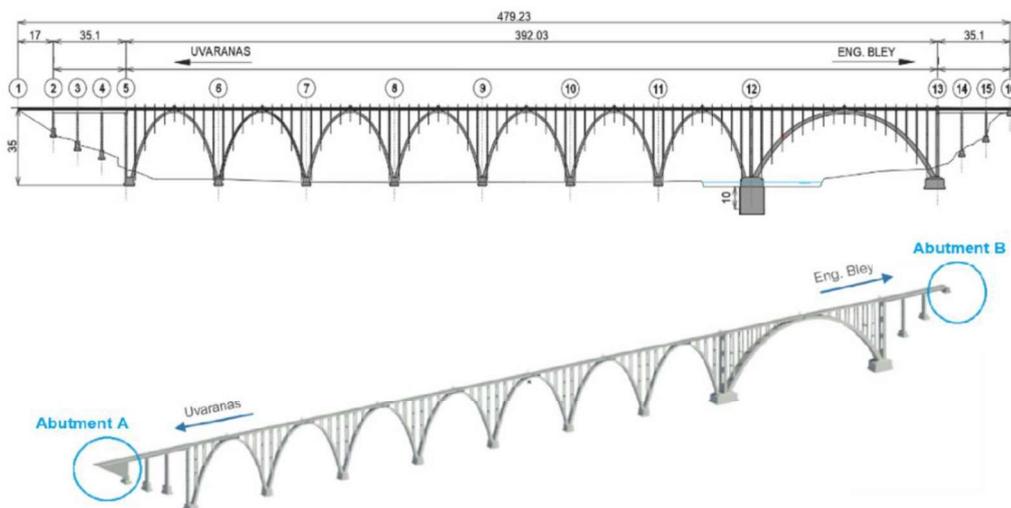
Figure 1 Papagaios Bridge

The Authors carried out a visual inspection to detect structural pathologies. Figure 3 and Figure 4 present a few examples. Bridge abutment B showed the most important structural damage including steel reinforcement corrosion, concrete spalling and – most important – a large shear crack at the bridge's shallow foundation under abutment B.

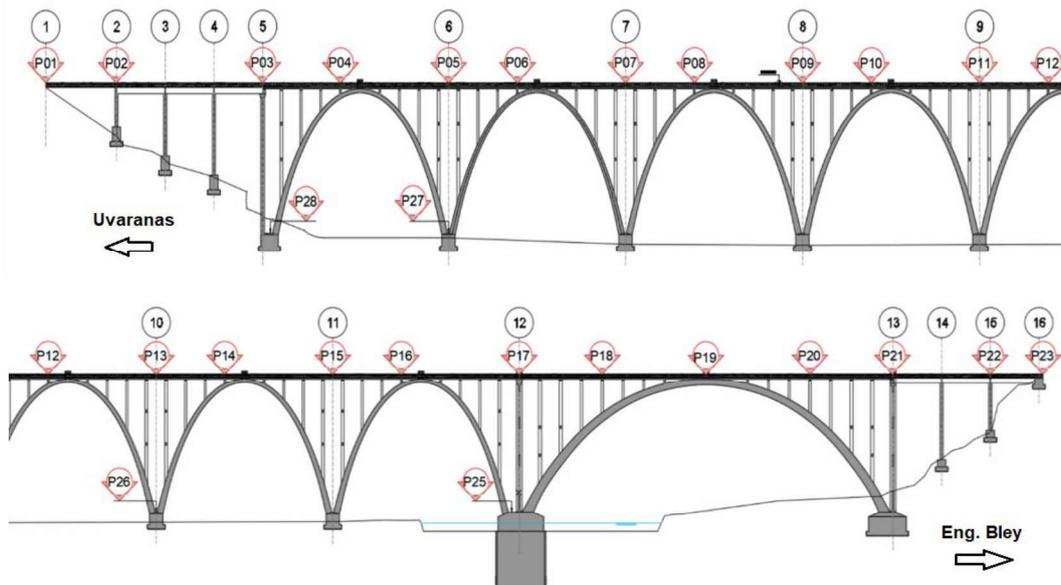
Figure 5 Measurement locations

A preliminary and undamaged numerical model of the structure enabled the selection of 28 measurement positions (**Error! Reference source not found.**) where the model indicated large amplitudes.

The measurements were carried out by two recorders on the bridge slabs and the top of the pillars. One recorder was placed in a fixed position, while the other recorded vibration on the previous measurement location. This led to a double measurement on each location and synchronization between all measurement locations.

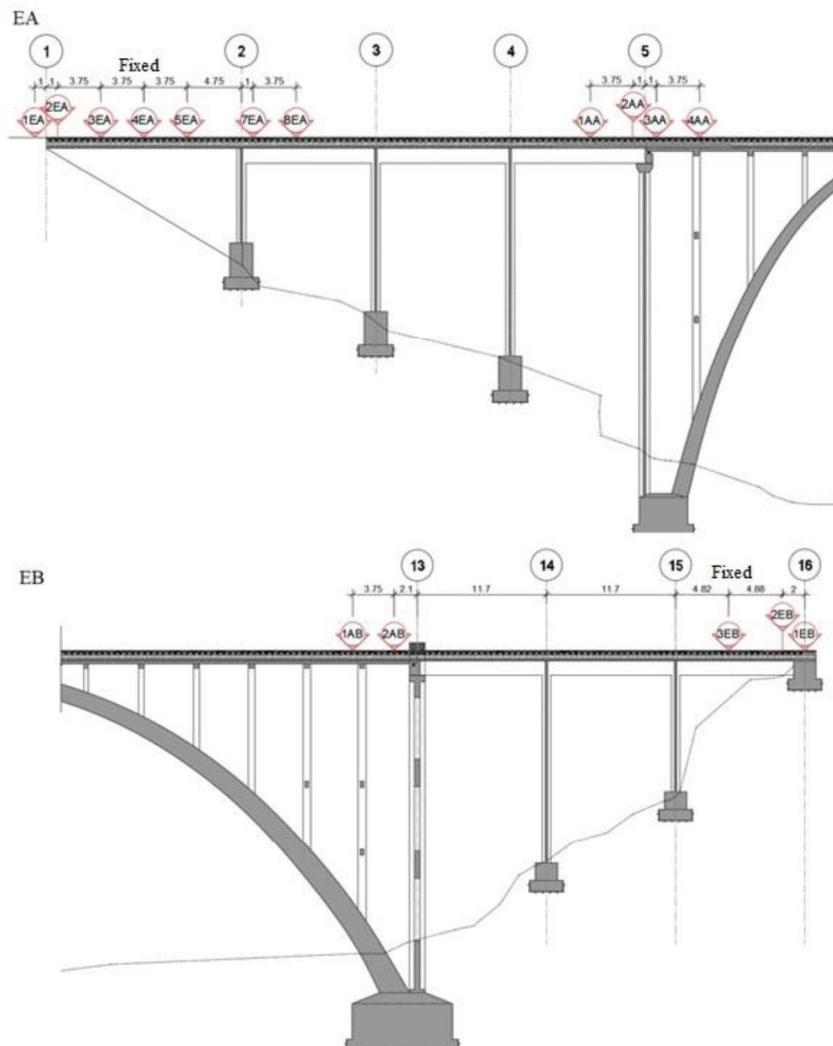
Figure 6 Measurement locations at the abutments A (top) and B (bottom)

Impact factors measurements were taken with a recorder on a fixed position on one sleeper (Figure 6), while the other, or the *traveller*, was positioned on various sleepers. These locations were previously selected (Figure 6) based on the preliminary numerical model which indicated locations of large vertical response when a train enters the bridge.

After completing the repairs, a second measurement campaign took place at Abutment B and extended to points P20 to P23 (Figure 6).

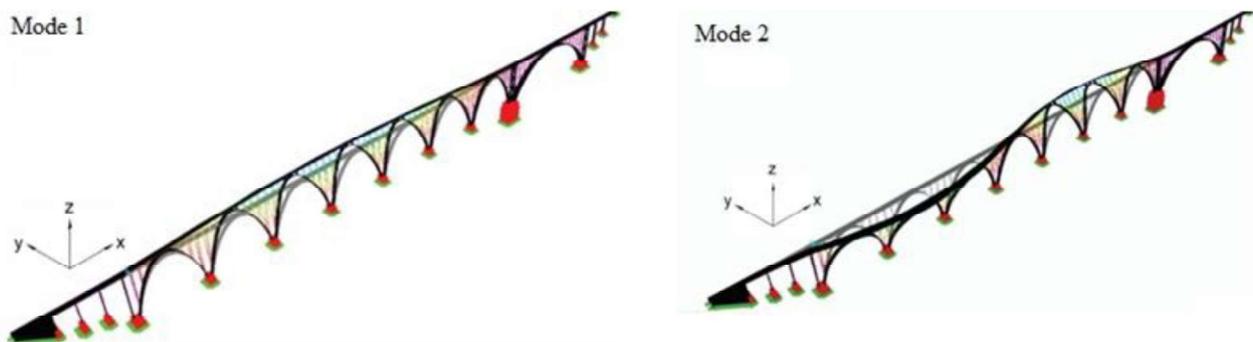
Figure 8 Numerical vibration modes

A preliminary numerical model yielded a first frequency equal to 0.55 Hz when using concrete Young's modulus of E =29 GPa. This modulus value was estimated for a concrete unconfined strength of 22 MPa, as used during the construction period.

The measured fundamental frequency of 0.635 Hz and the other of the table were obtained by processing the data and statistical analyses. To calibrate the numerical model with the first frequency it was necessary to increase Young's modulus to 40 GPa, which agrees with values found in the literature (Altunisik et al, 2016, Turker et al, 2014). Figure 8 shows the calibrated model.

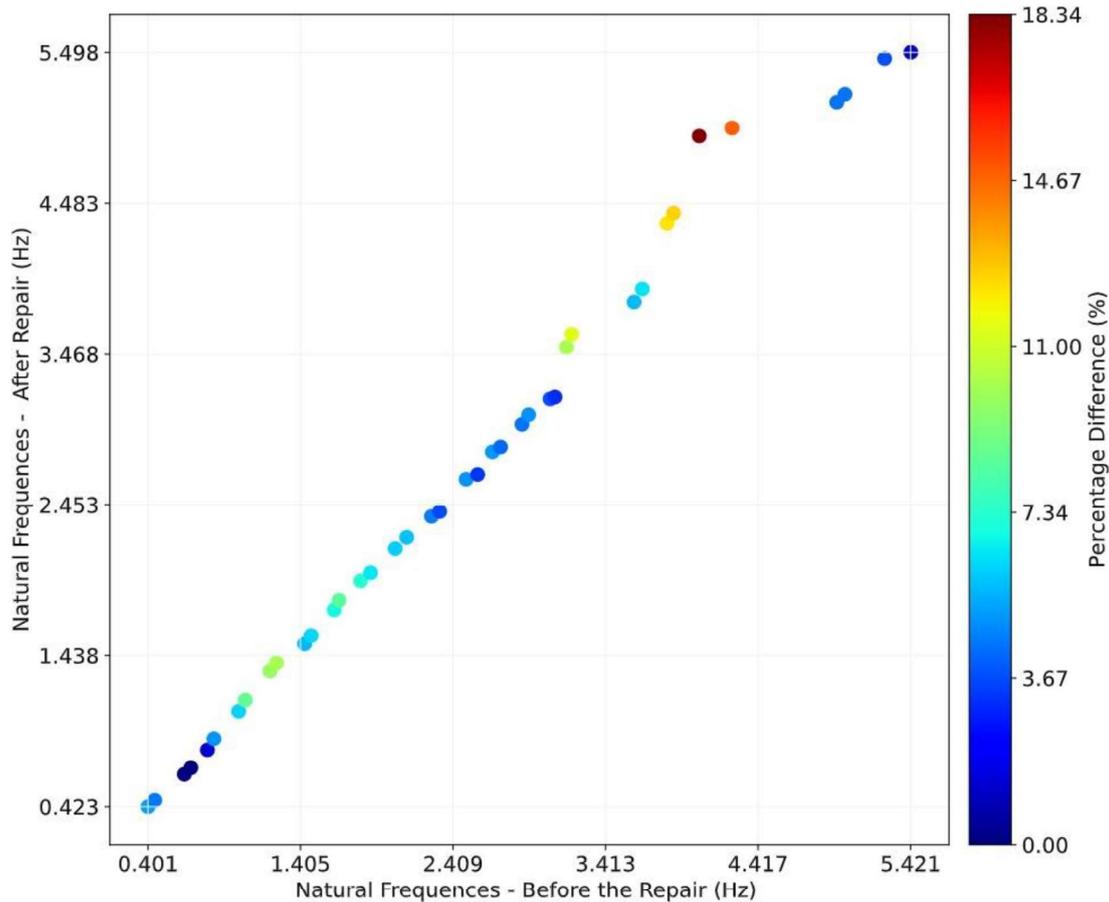
Figure 9 Comparative between natural frequencies after and before repairs.

Point P23 of abutment B was selected for comparing results before and after repairs. It returned the same number of frequencies between campaigns in a frequency close to 5.5 Hz. Figure 13 presents measured frequencies before and after repair. The vertical colour scale indicates the change in frequency. Blue points indicate no significant frequency change, while the red ones indicate change.

The larger frequencies in Figure 13 correspond to 5.423 Hz and 5.499 Hz, in which the difference is so small that cannot be used to indicate any significant change in stiffness. Also, the transverse

modes cannot be used to indicate a change of stiffness, therefore the OMA cannot indicate damage in this bridge.

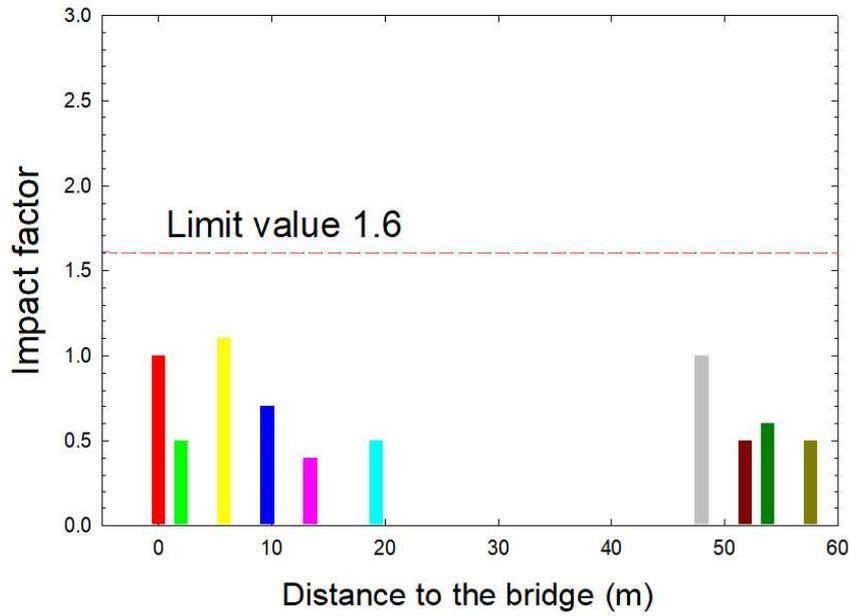
Figure 10. Dynamic Amplification Factors DAF– Abutment A (no repairs)

The vertical response of the bridge is given by the integration of measured accelerations and normalized to the fixed position measurement. Figure 10 presents the results for abutment A, showing low values below 1.2, therefore acceptable impact values (ABNT NBR 7187). On the other hand, Figure 11 presents results from abutment B, showing high values up to 2.6 before repairs and how much they decreased after the repair works.

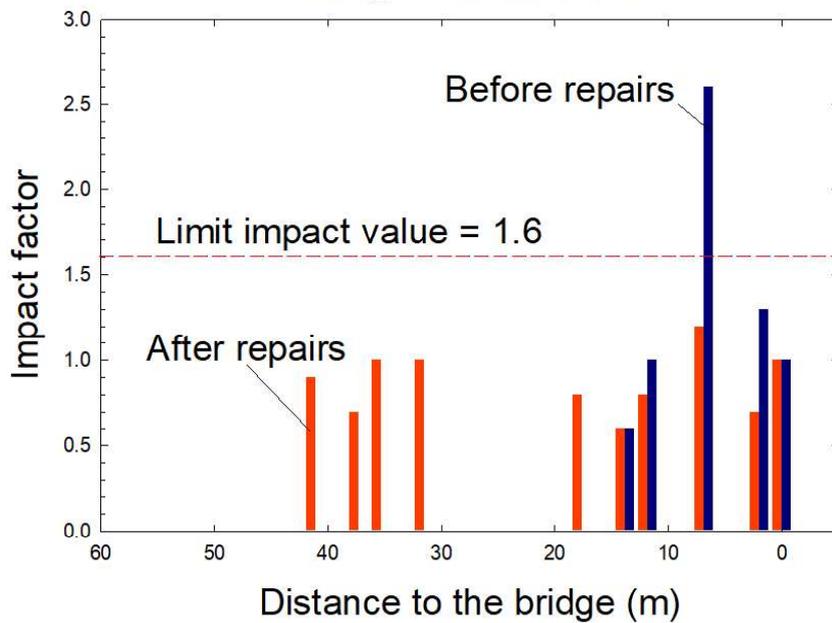
Figure 11. Dynamic Amplification Factors DAF– Abutment B, before and after repairs

The good performance of abutment A was confirmed by the assessment of impact factors, or DAF. At abutment B, however, measurements before repairs showed high impact factors, up to 2.6, but reduced values, below 1.2, once the repairs were made.

The client carried out emergency repairs at abutment B (Figure 7) which consisted of demolishing the damaged areas, using rock bolts and new rebars and additional concrete.
